Ground Improvement for Khulna Soft Clay Soil

Final Report

Mott MacDonald

AsCAP Project Reference Number. BAN2083A

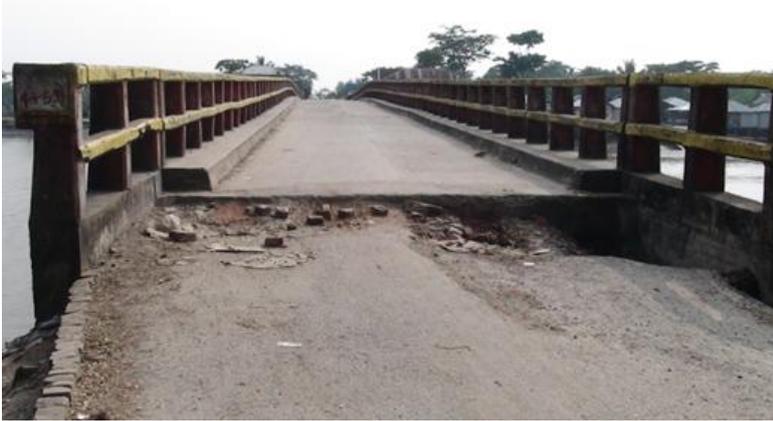
Feature / defect	Example
Differential settlement adjacent to structures (Site 21 – 201582003)

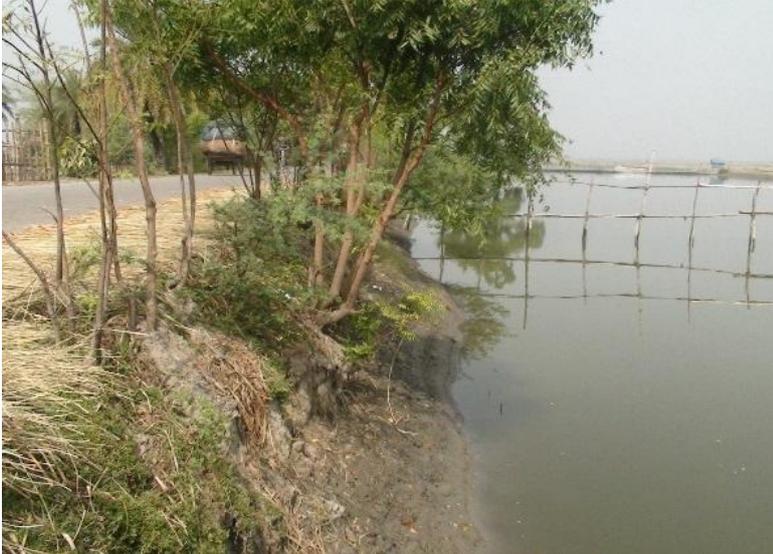
Erosion / over-steepening of the embankment slopes (Site 3 – 287042008)

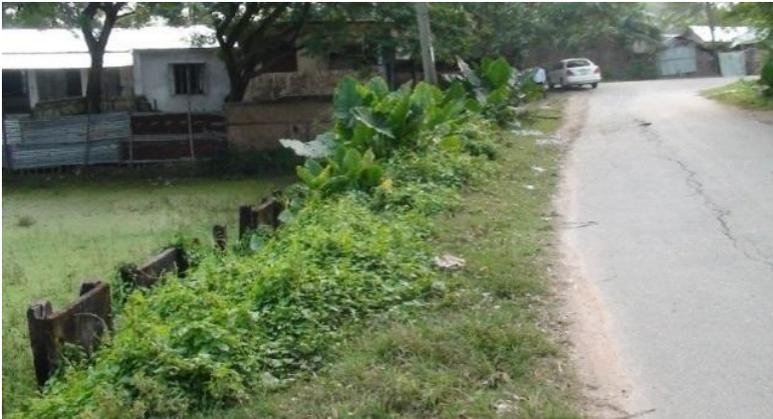
Longitudinal cracking towards the edge of the road pavement (Site 10 – 247302001)

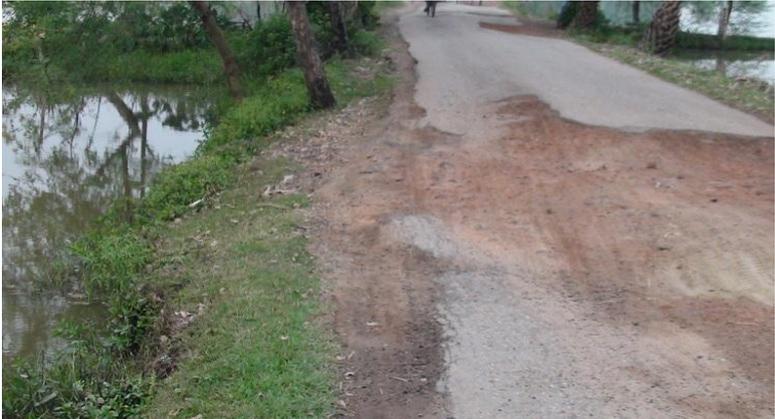
Feature / defect	Example
Lateral spreading of the embankments (Site 11 – 247303003)

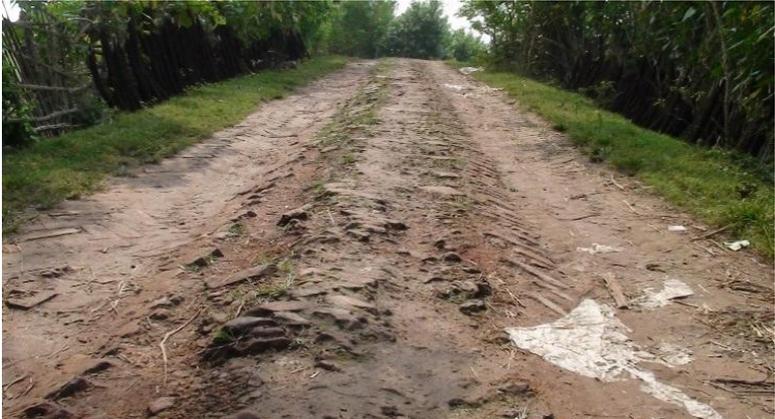
Poor road surface conditions / potholes are widespread (Site 6 – 247172001)

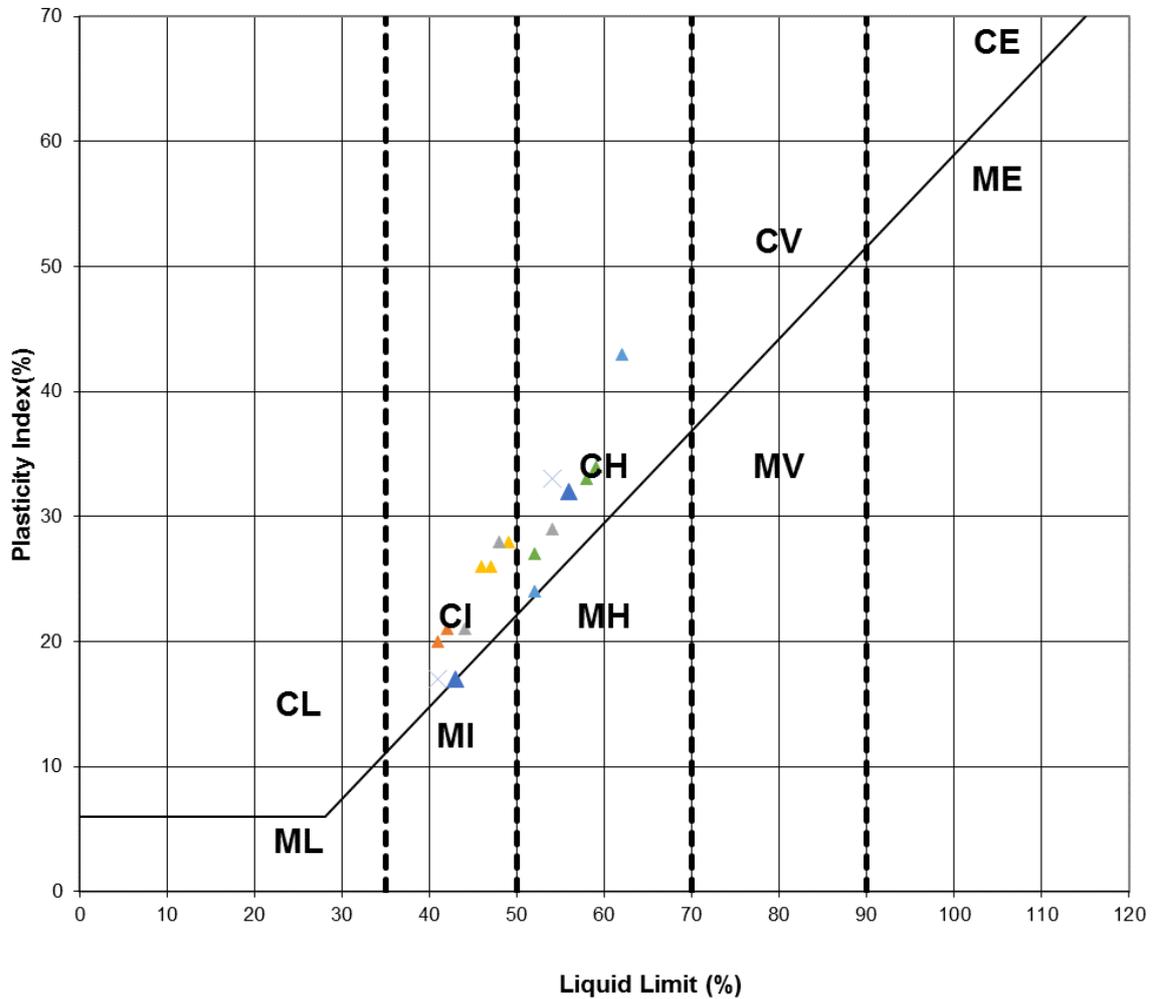
Figure 3 A-Line Plasticity Chart

▲ Site 11 ▲ Site 3 ▲ Site 10 ▲ Site 12 ▲ Site 15 ▲ Site 13 × Site 21

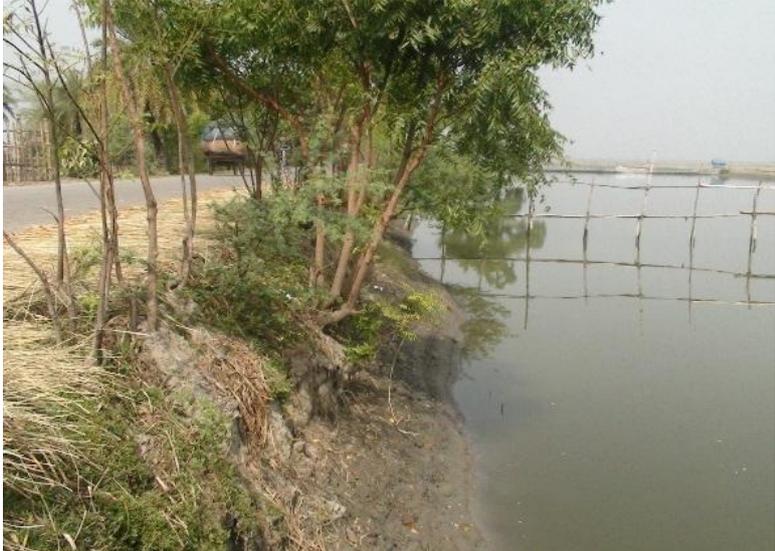
Key features	Site photograph
Erosion, over-steepening of the embankment slopes at Site 3

The embankment fill consists of Fat Clay material and generally has a cone resistance that reduces from the near surface layers to the base of the embankment illustrating probable poor compaction and consequently higher water content, leading to low strength and support characteristics. Little self-weight compaction is likely due to the low height of the embankment, with only the near surface pavement layers (comprising higher quality material than the general embankment fill) demonstrating significant resistance to cone penetration.

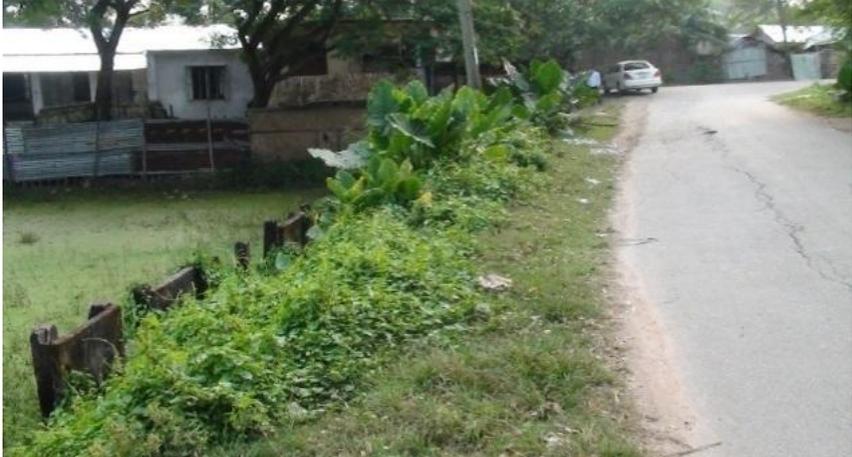
Key features	Site photograph
Longitudinal cracking towards the edge of the road pavement at Site 10

The main body of the embankment is composed of a Lean Clay and a Lean Clay with Sand. This placed embankment fill material generally has a cone resistance of 2.5 to 9.5 MPa. Resistance within the embankment fill drops from the more competent near surface layers and then increases towards the base of the embankment fill and into the foundation soil. This illustrates probable poor compaction of the fill material, leading to low strength and support characteristics.

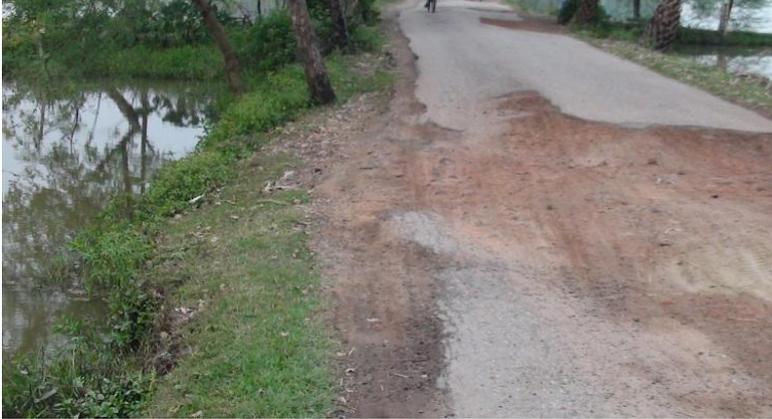
Key features	Site photograph
Lateral spreading of the embankments at Site 11

The main body of the embankment is composed of a Fat Clay and a Fat Clay with Sand. This placed embankment fill material generally has a varying cone resistance of less 2 MPa to approximately 10 MPa. There is a distinct reduction in strength (Test 2 and 3) below the pavement layers, before this recovers from 1mbgl. The Fat clay will experience volume change during wetting and drying, due to the known changes in water levels that this site experiences during flooding.

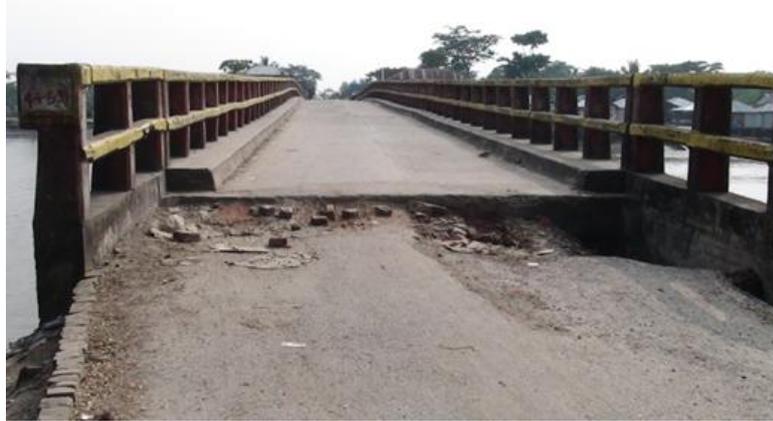
Site photograph

The road embankment is constructed predominantly from Lean Clay and Fat Clay with Sand. At Mongla A - the placed embankment fill material generally has a cone resistance of 1.5 to 4 MPa. At Mongla B - the placed embankment fill material generally has a cone resistance of 20 MPa near the surface, dropping to around 4 MPa, the higher values reflecting the influence of broken brick aggregate near the surface.

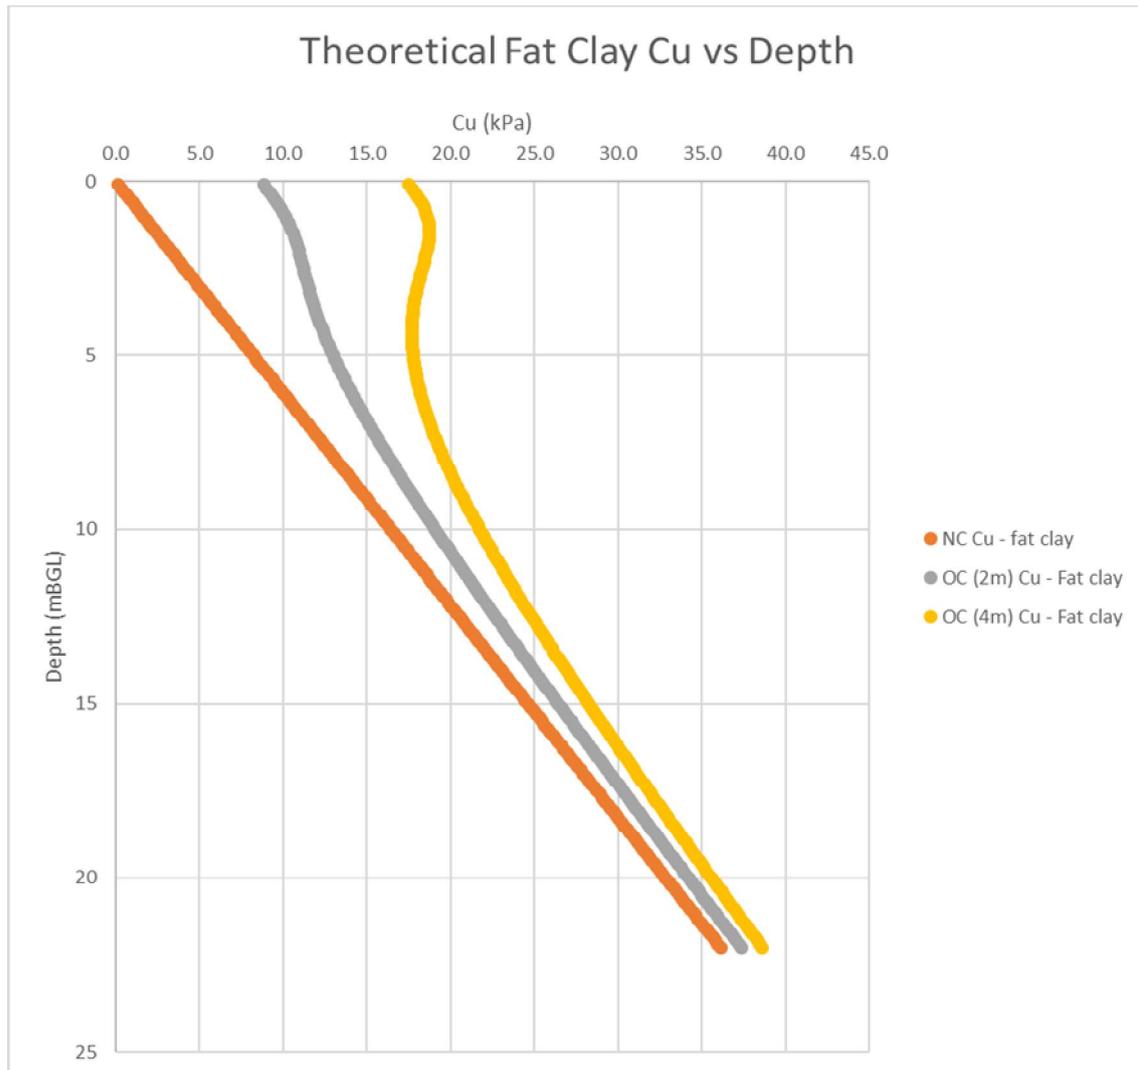
Figure 13: Improvement in undrained strength resulting from embankment construction on Fat Clay foundation soil

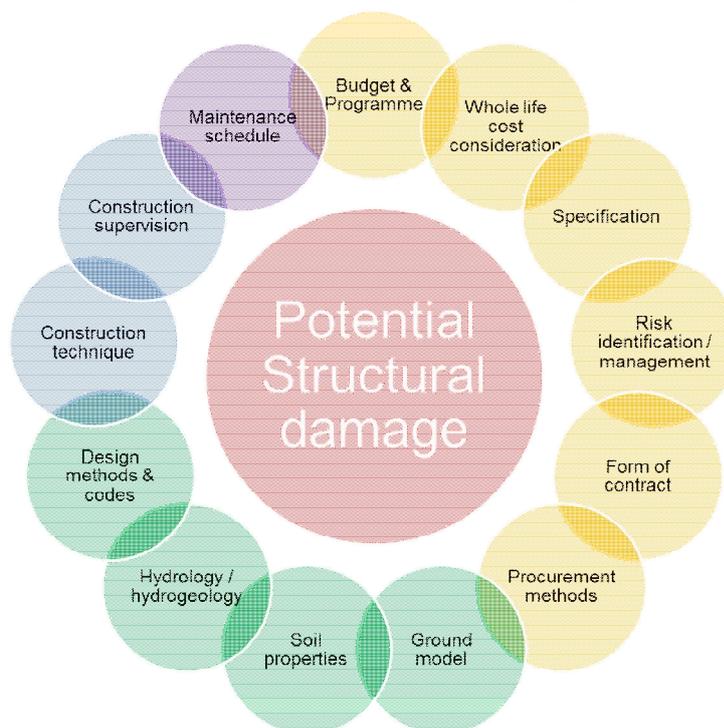
Figure 15: Factors that influence the potential for damage to structures and earthworks through the asset lifecycle

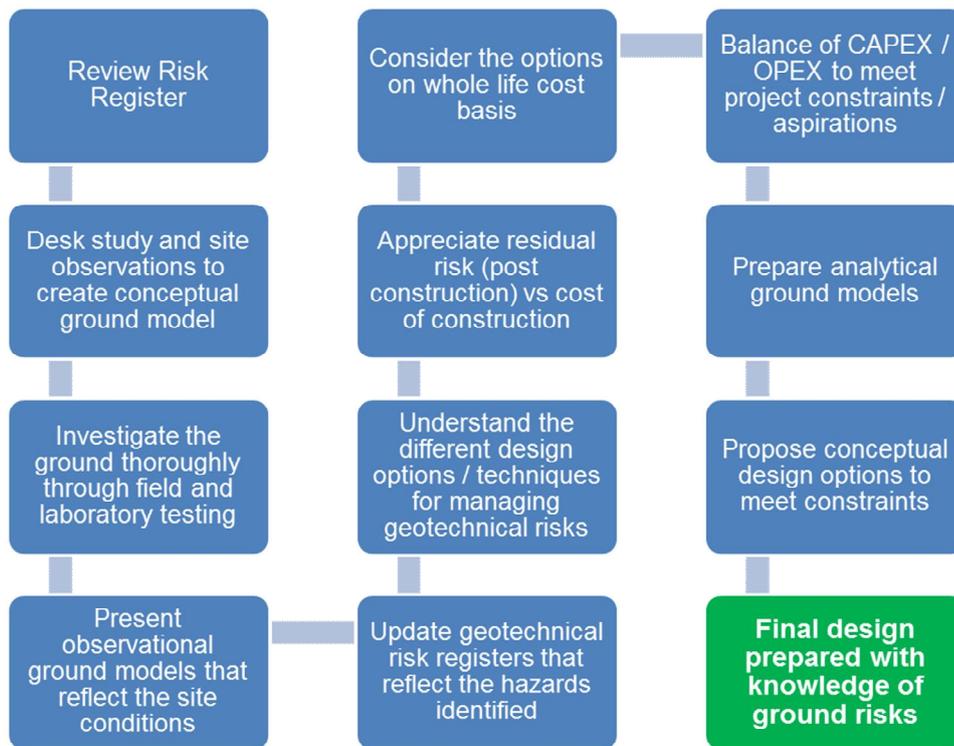
Figure 16: Design Phase – Management of Risks associated with Soft Ground

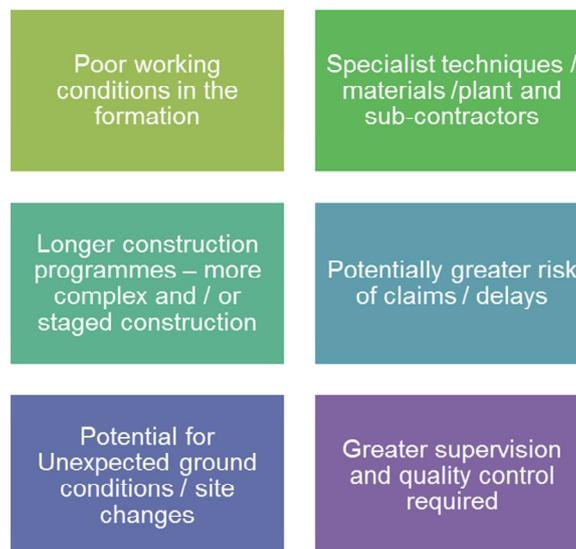
Figure 18: Construction Phase issues associated with soft ground

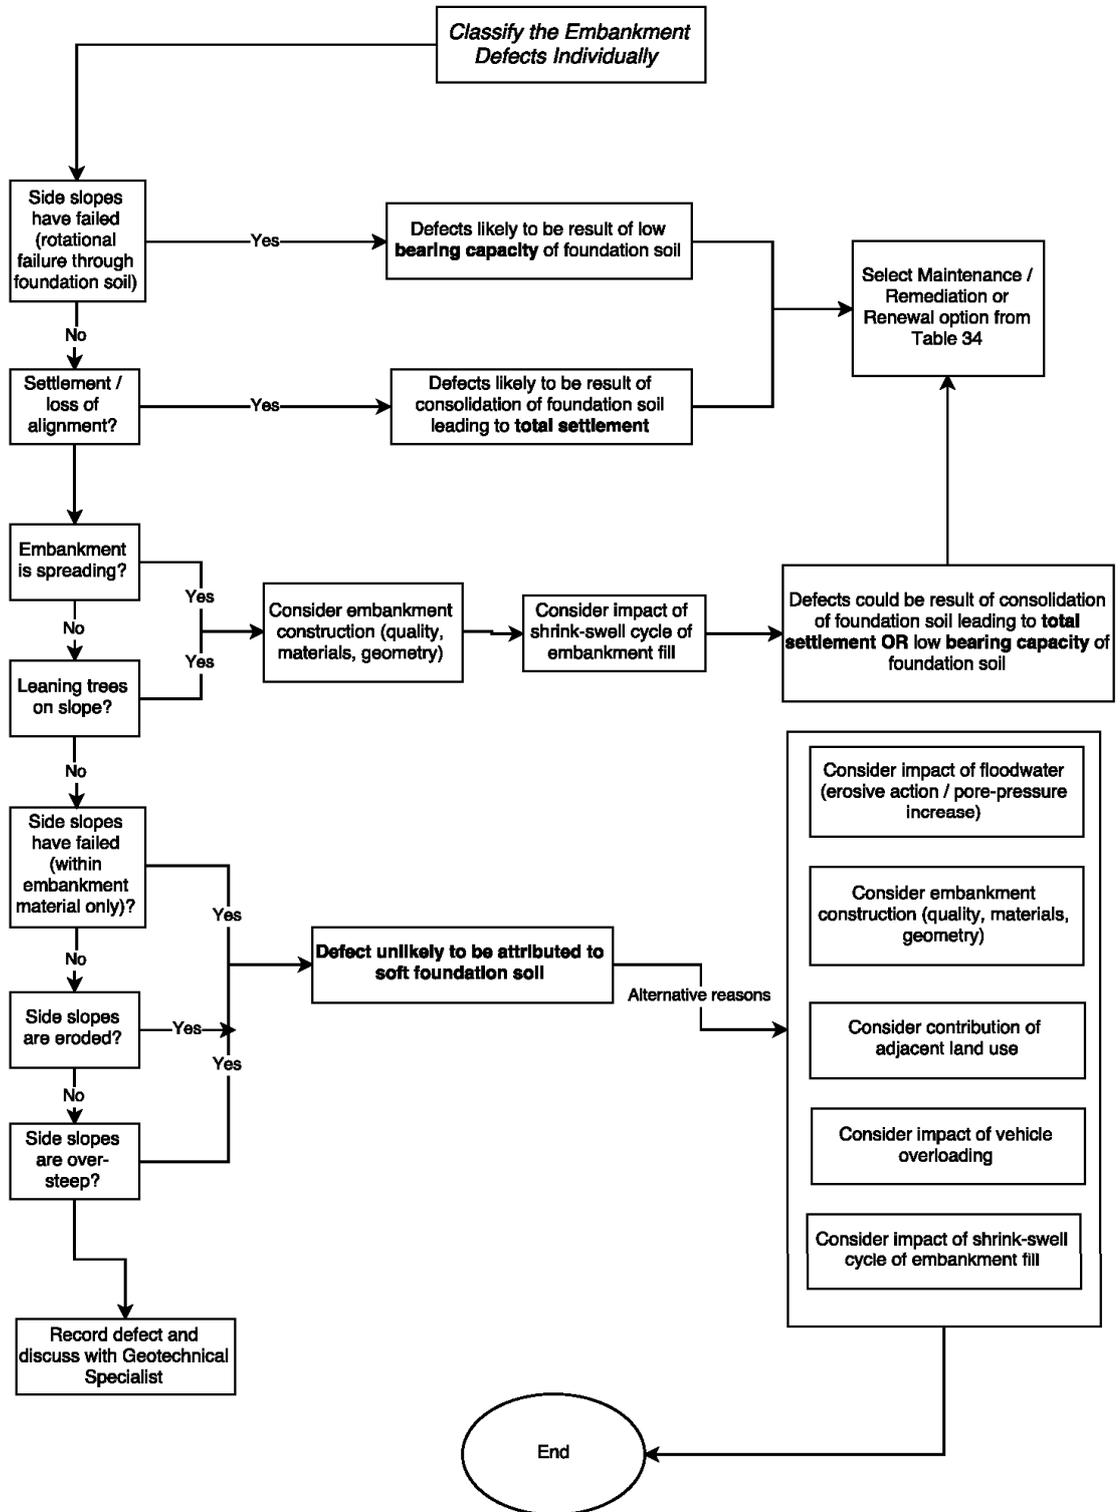
Figure 20: Classification of embankment defects

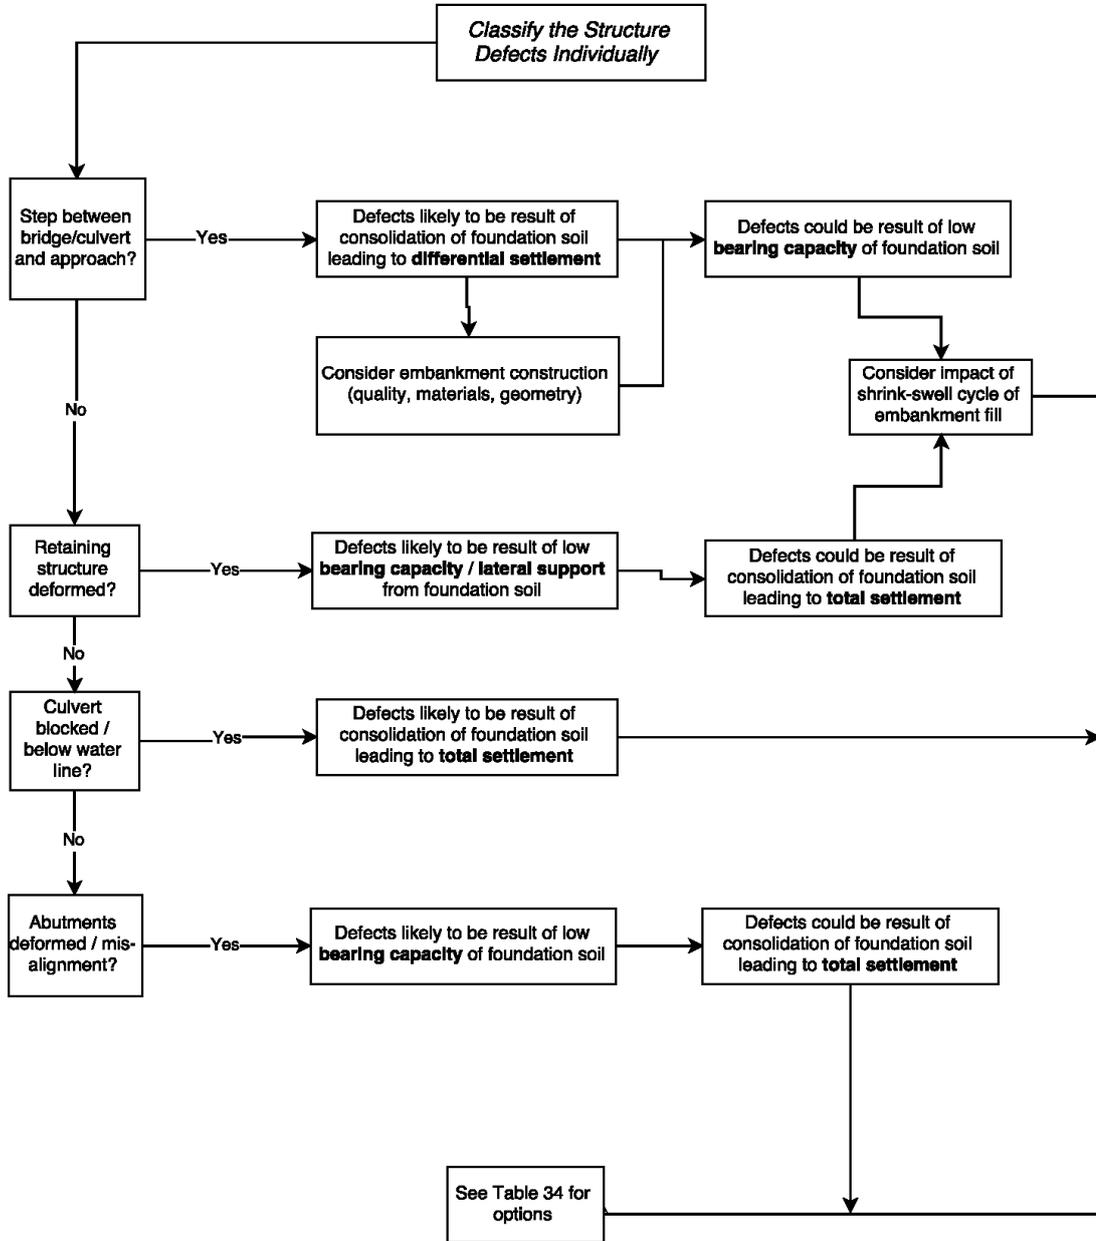
Figure 21: Classification of structure defects

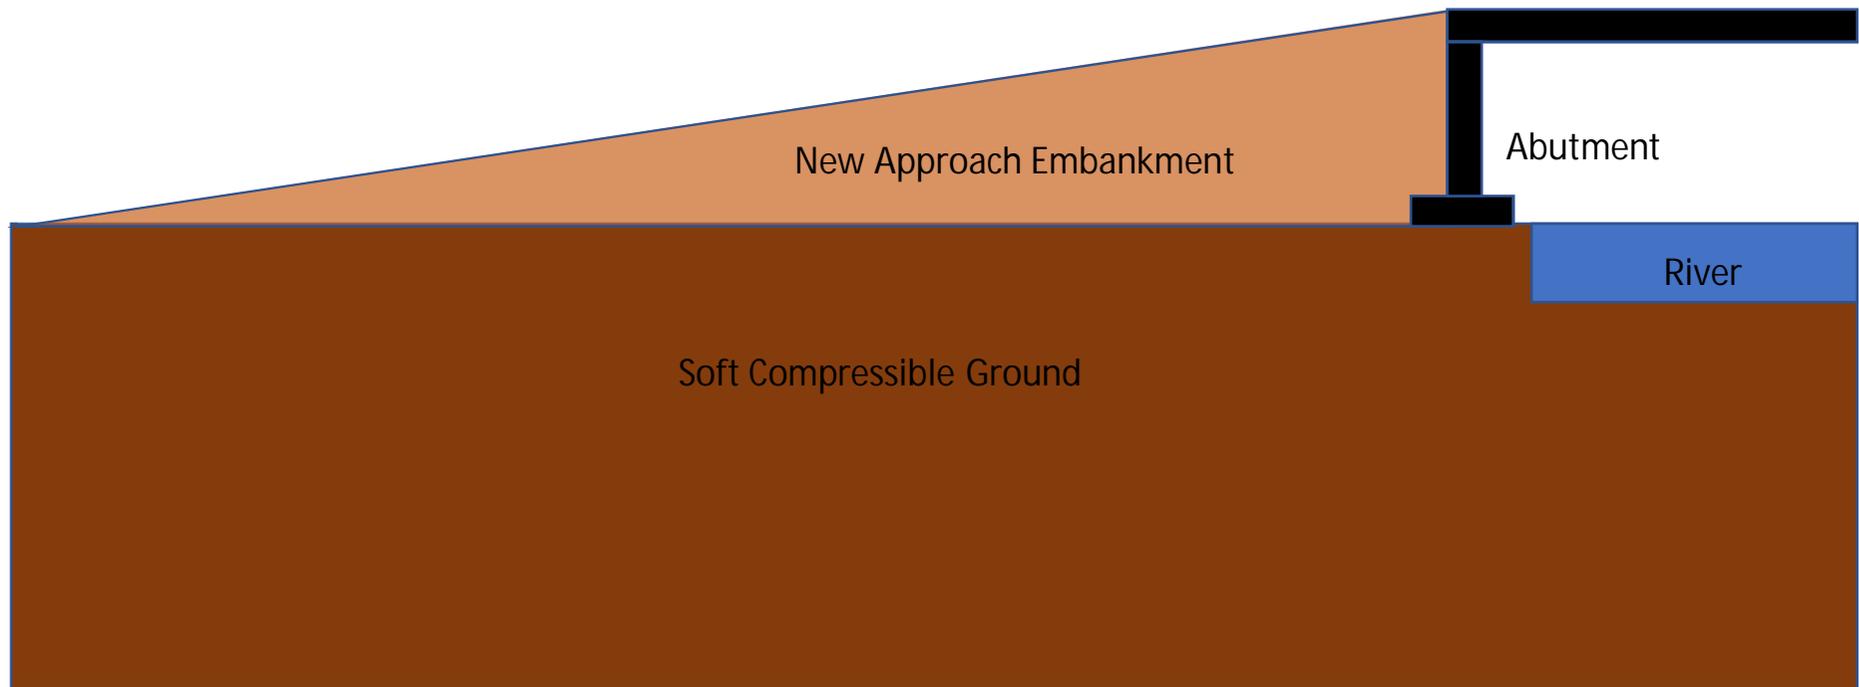
Ground Model

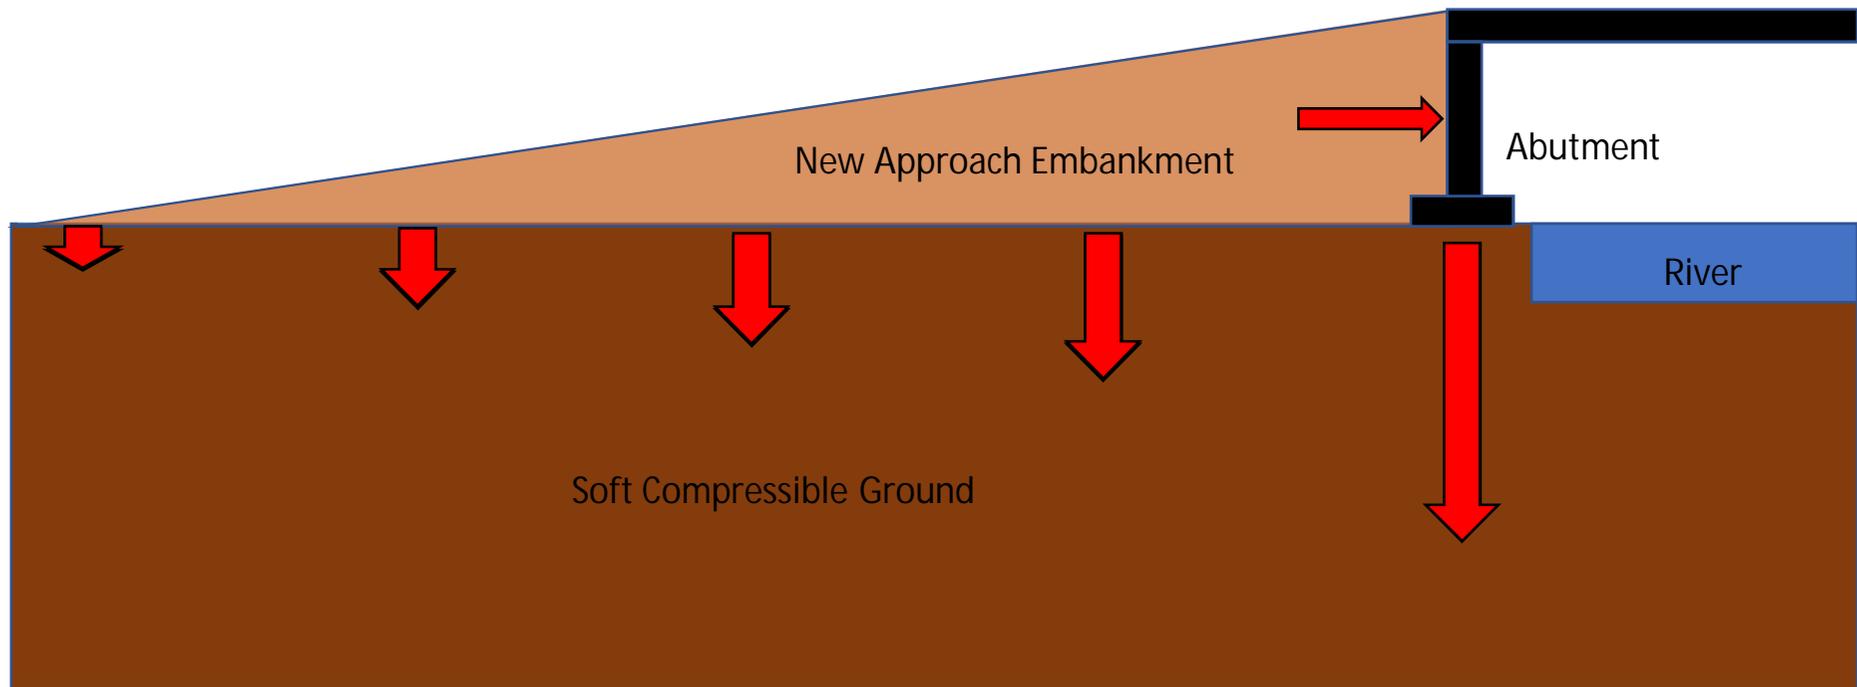
Ground Model – load from earthworks and abutment

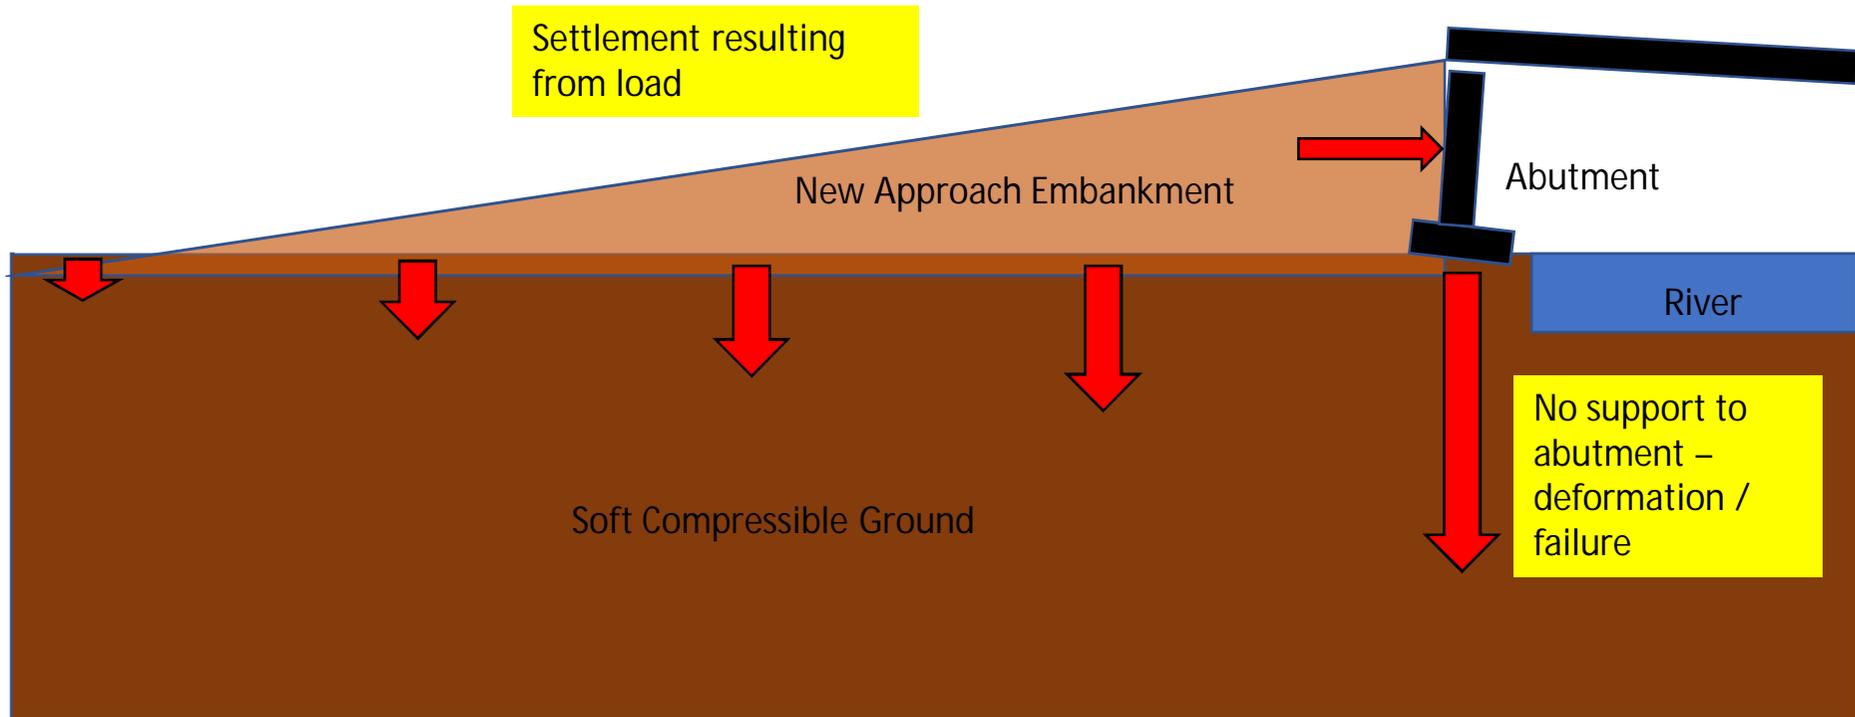
Ground Model – ground response to load – settlement, failure

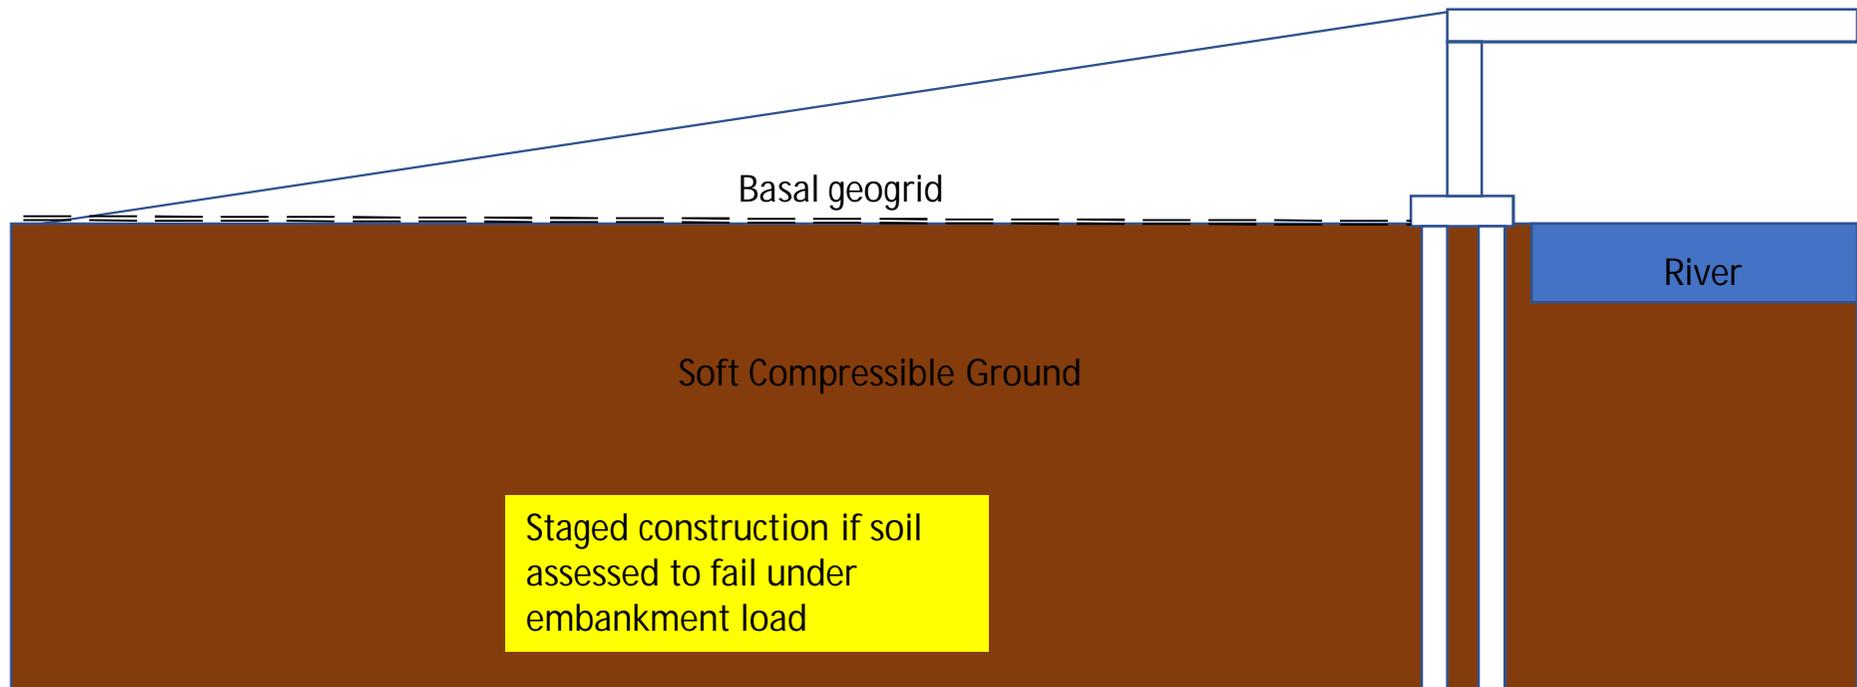
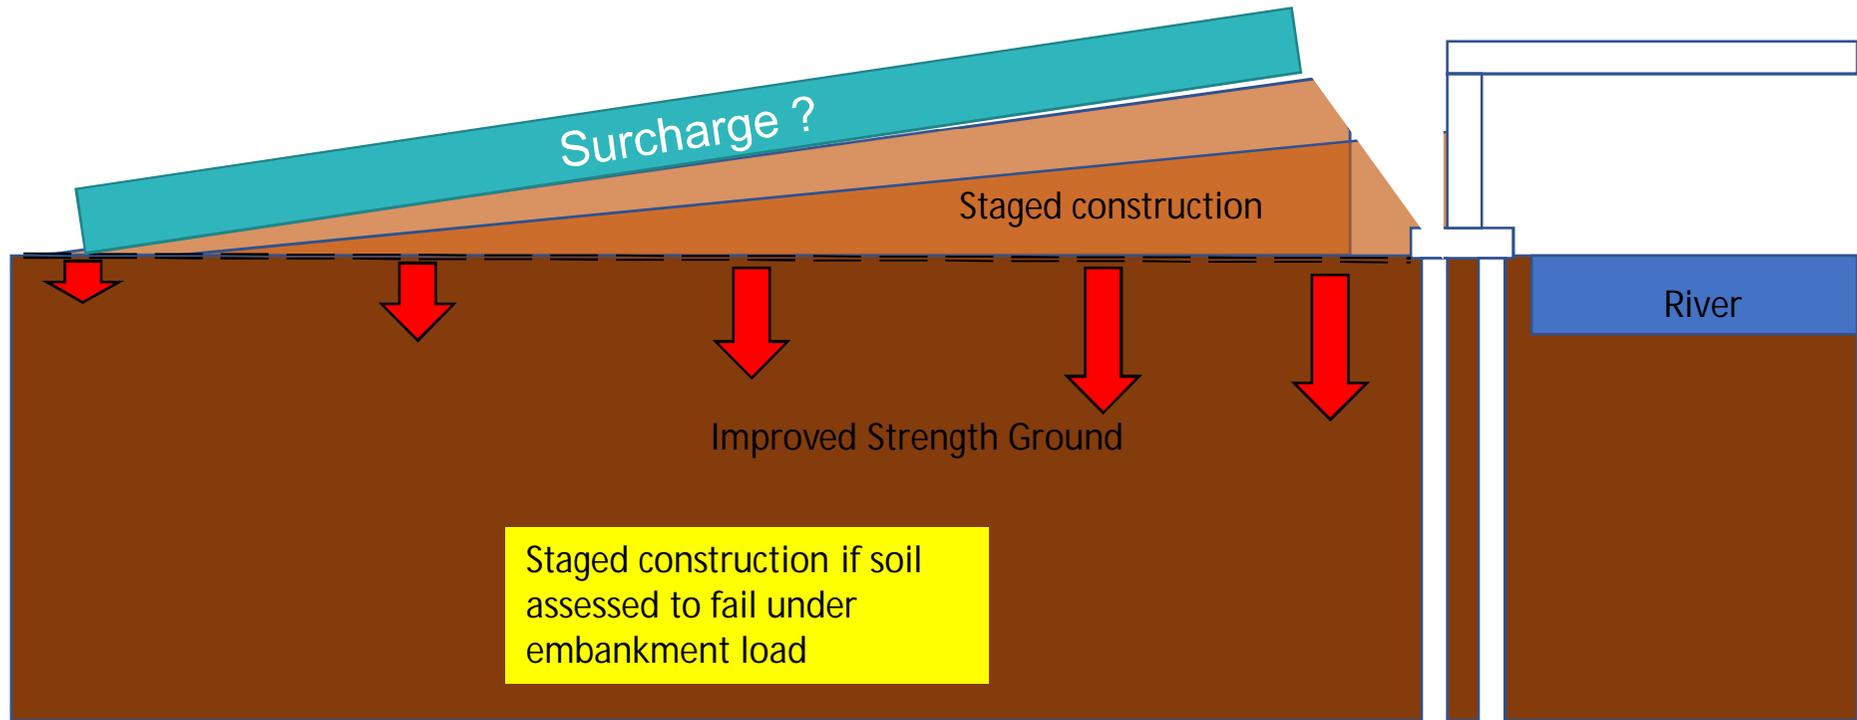
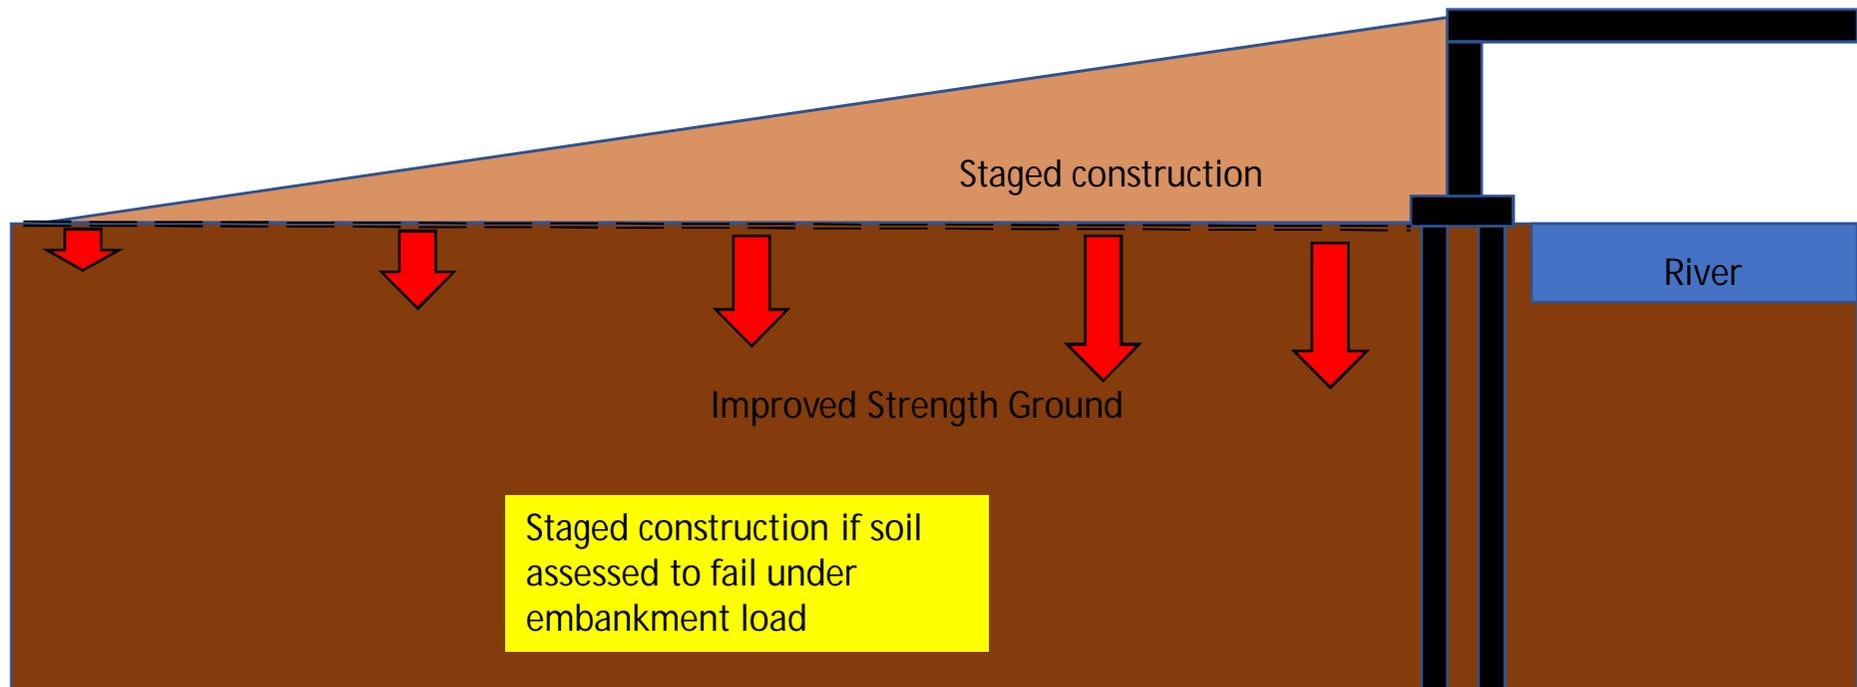
Build embankment first – staged construction with basal geogrid (+ surcharge); support abutment with piles
