Ground Improvement for Khulna Soft Clay Soil

Final Report

Mott MacDonald

AsCAP Project Reference Number. BAN2083A

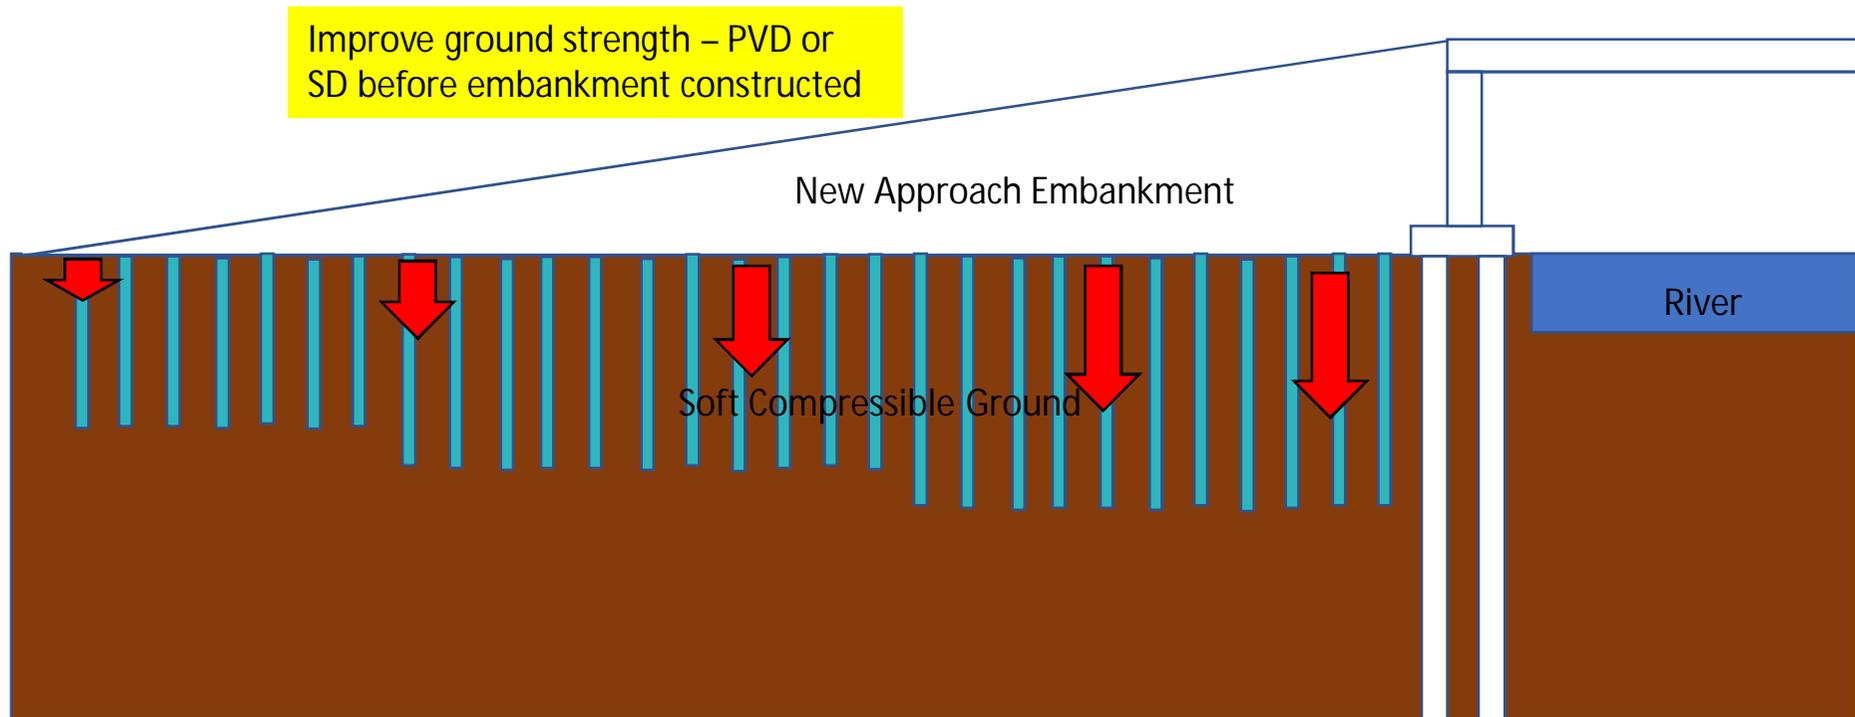
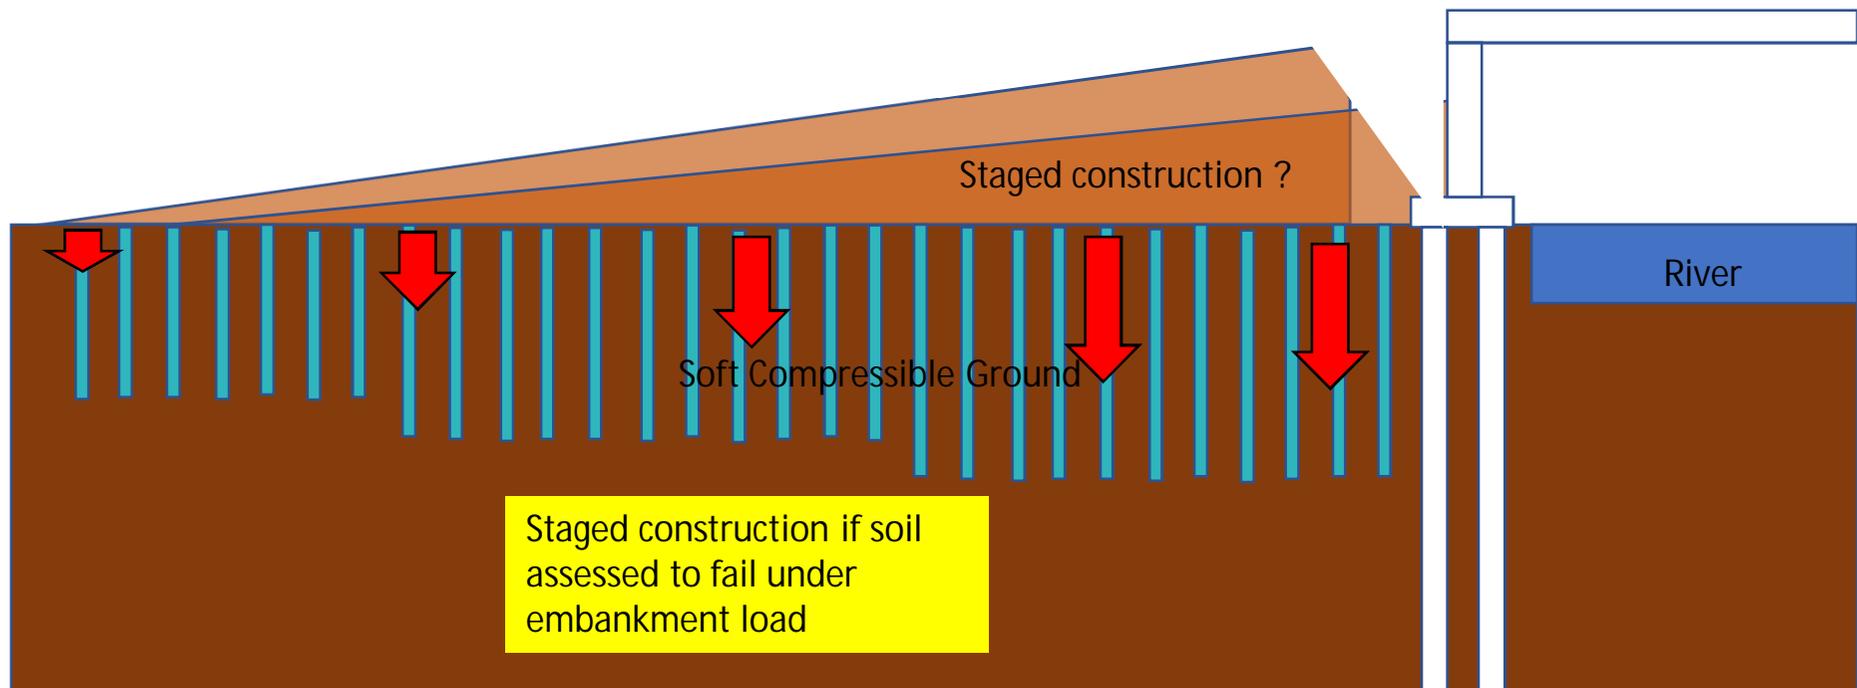
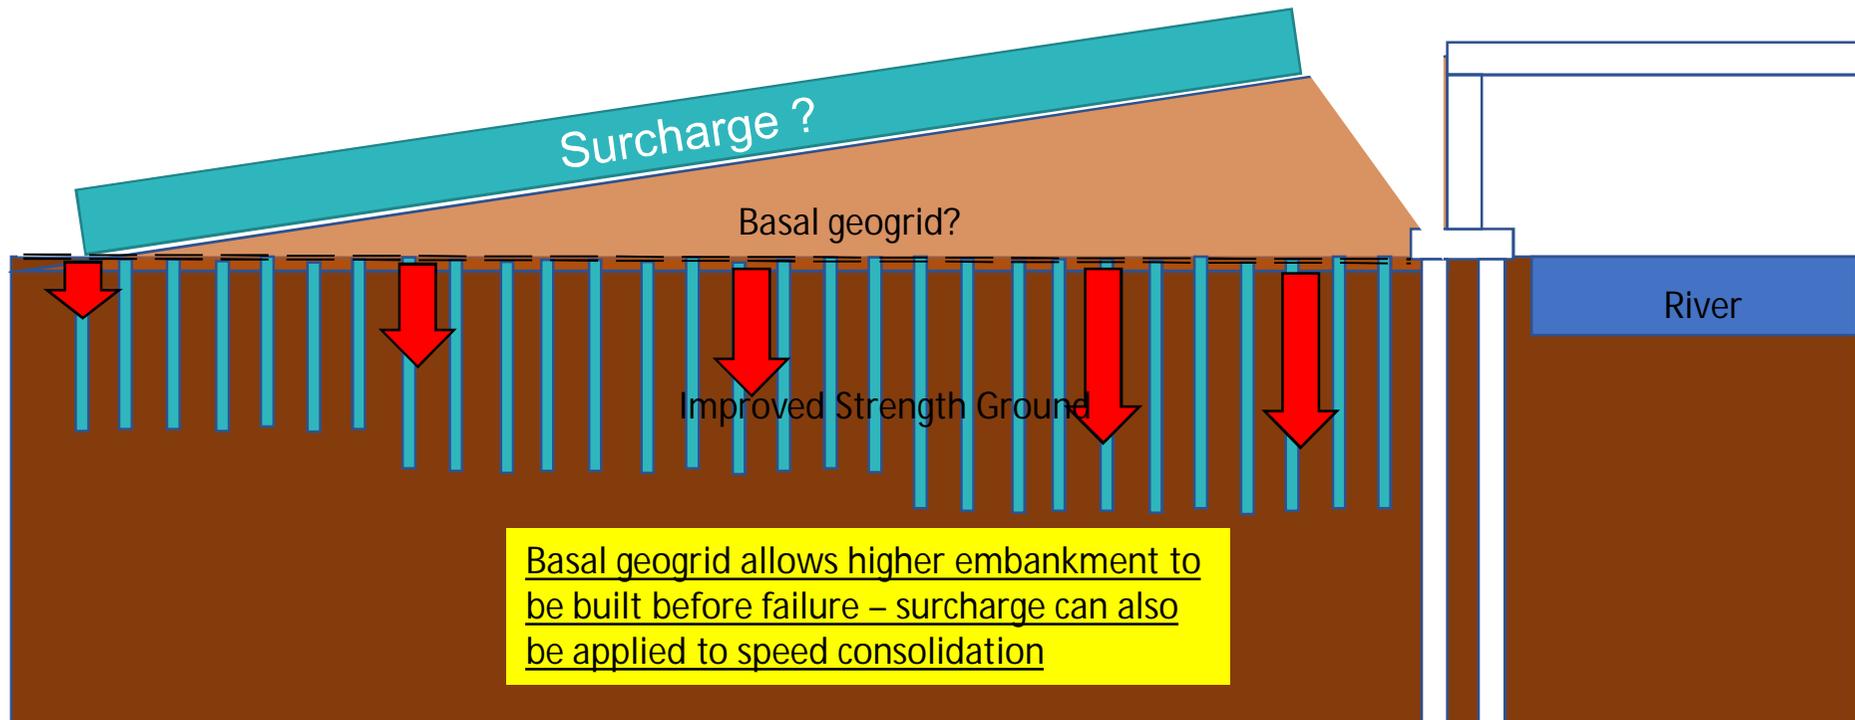
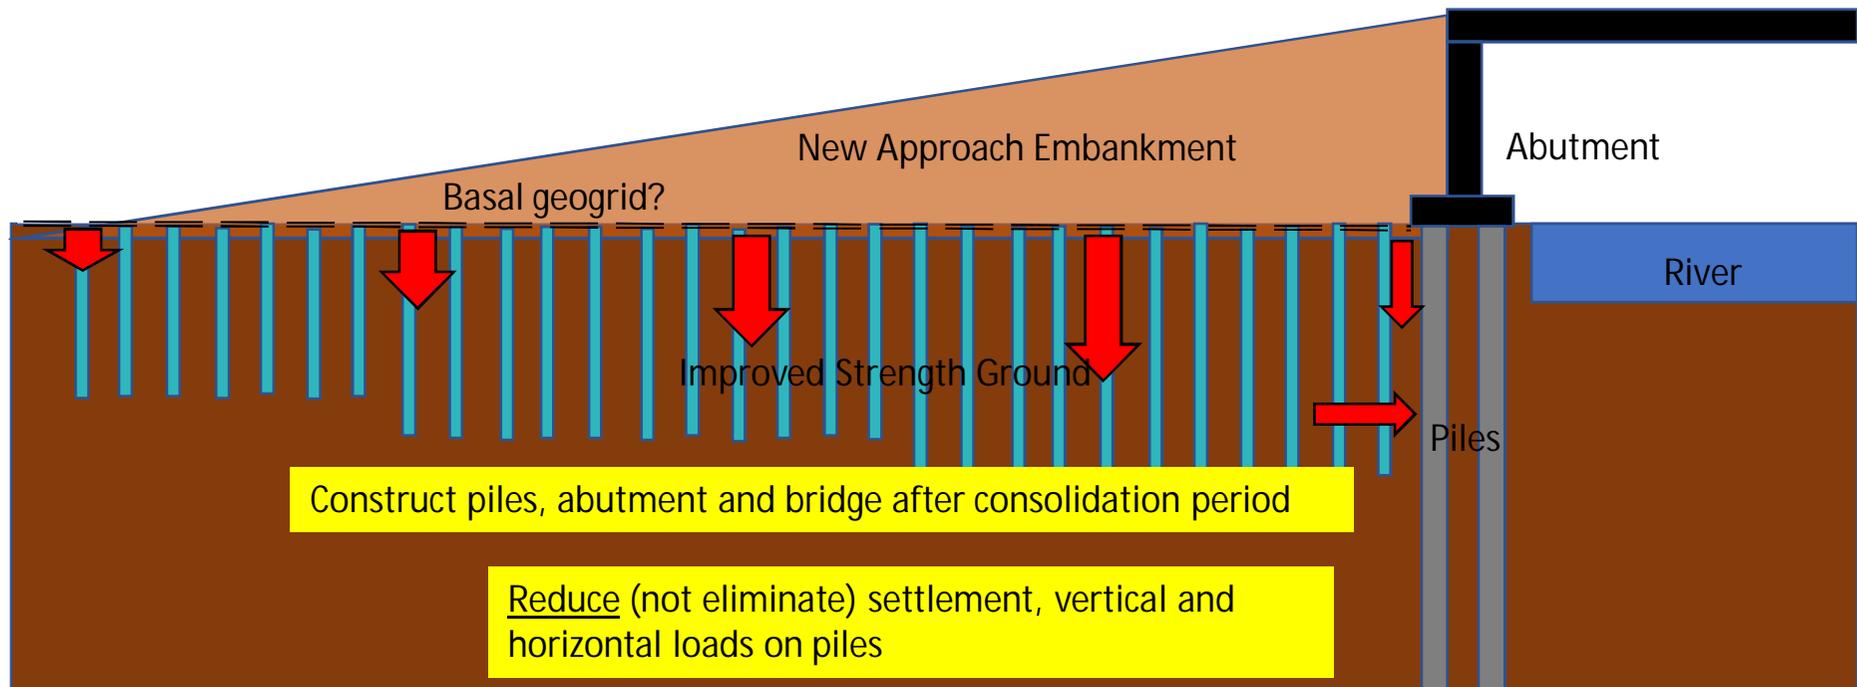
Build embankment first – with vertical drains (+ surcharge); support abutment with piles

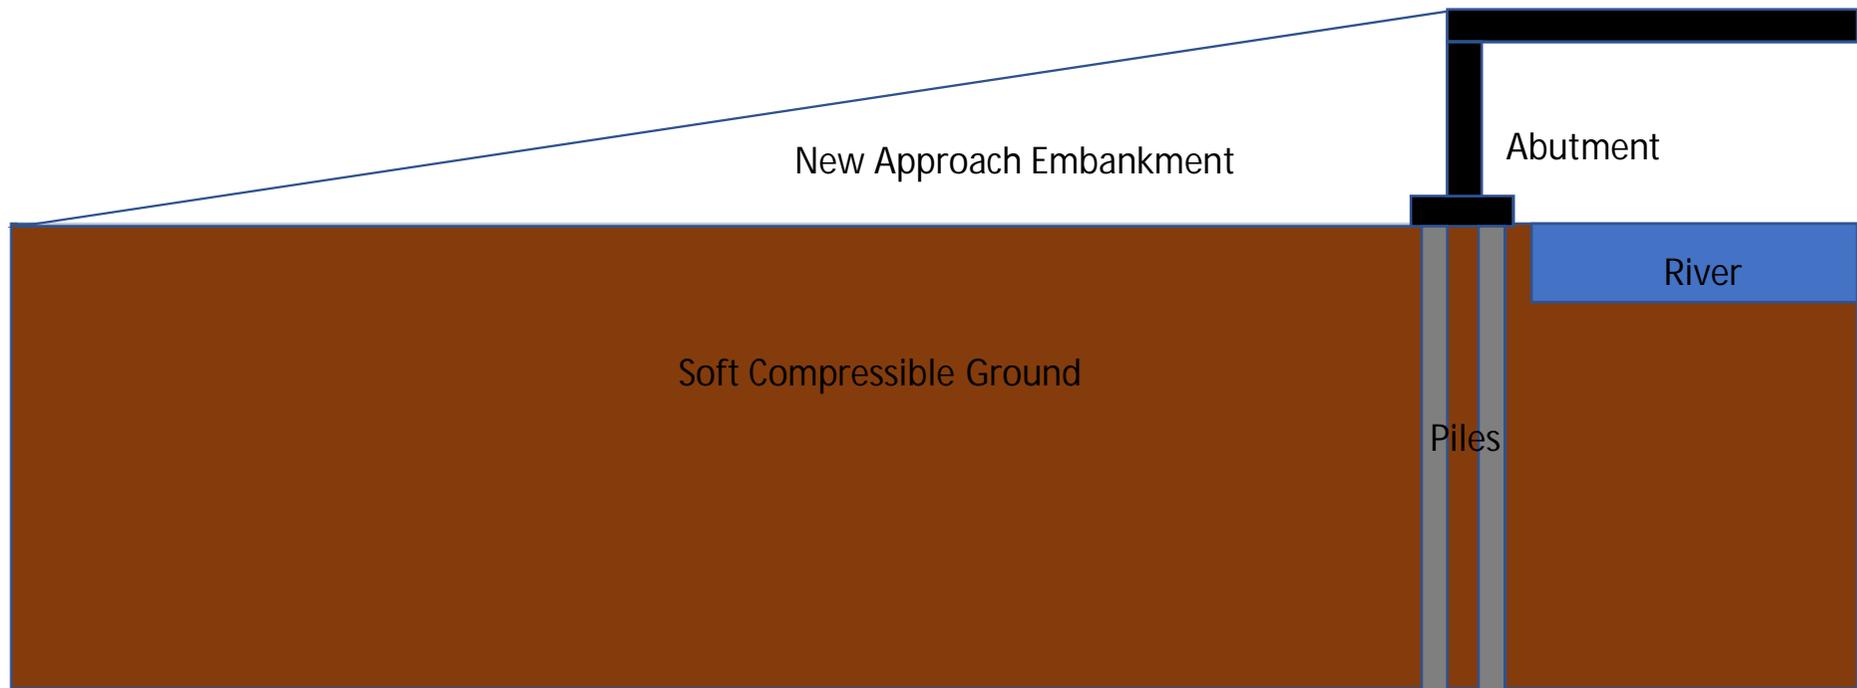
Bridge built first – support abutment with piles

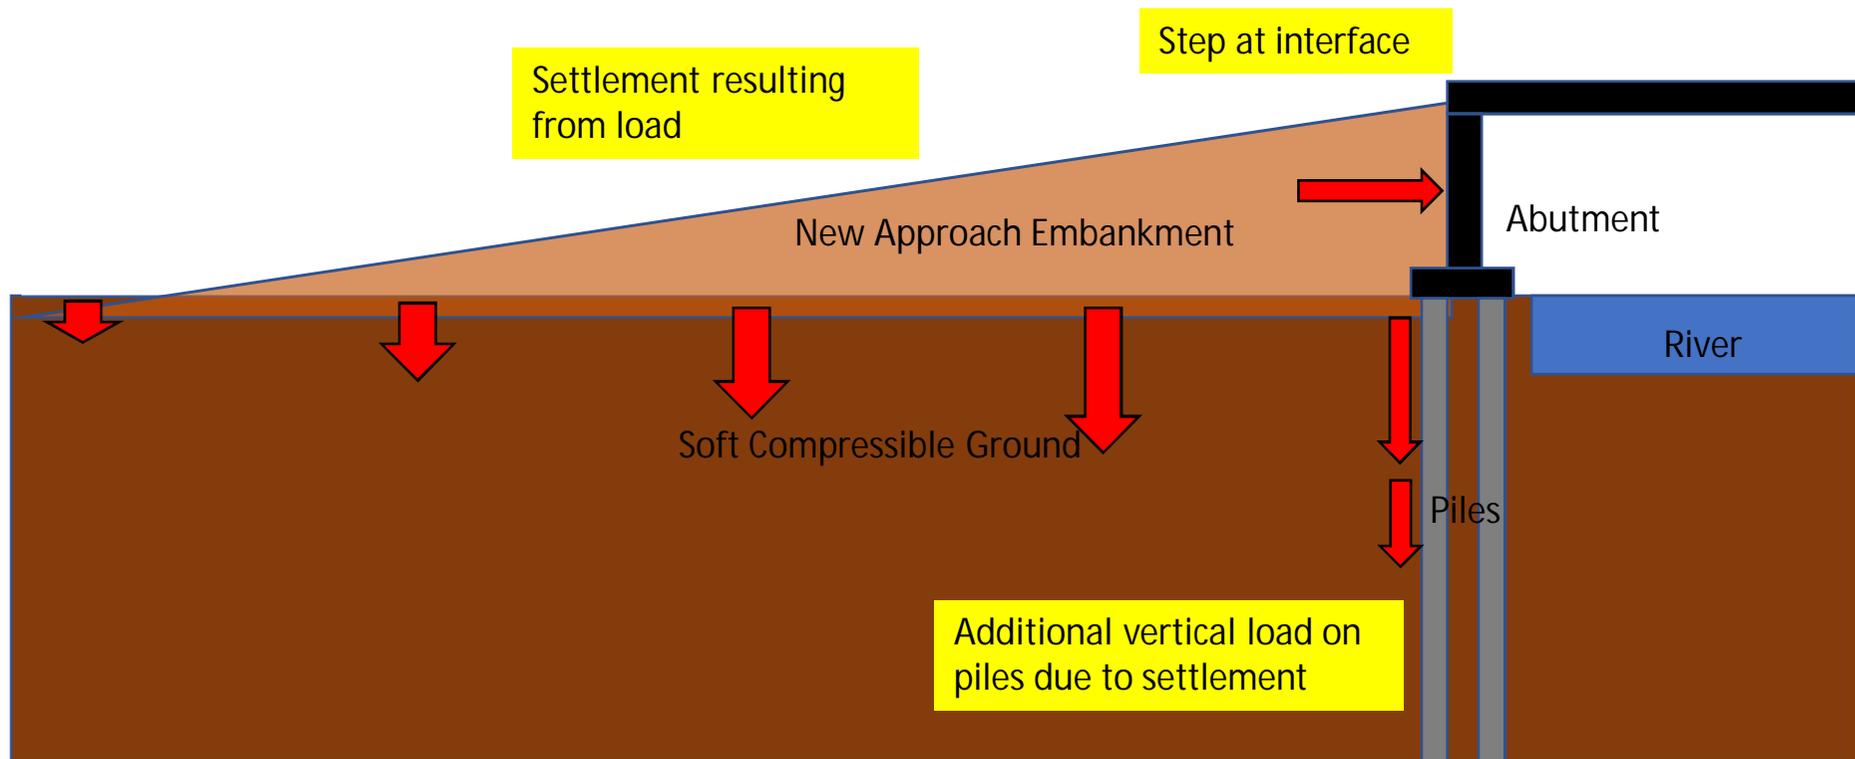
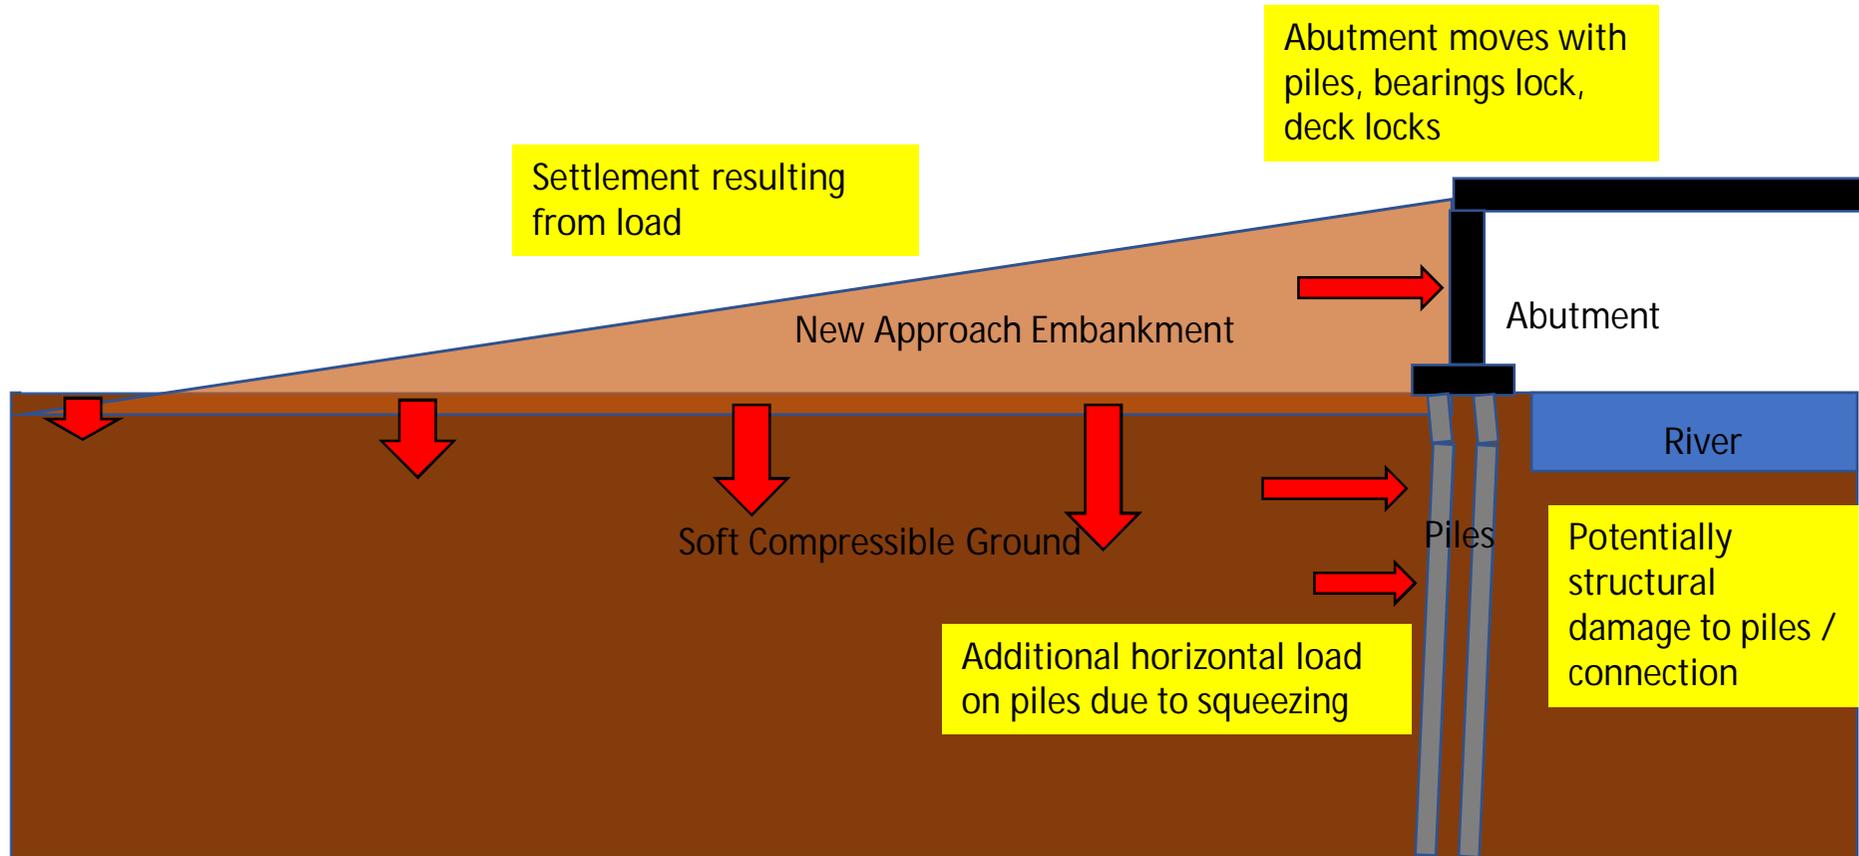
Bridge built first – support abutment with piles – can result in serious damage

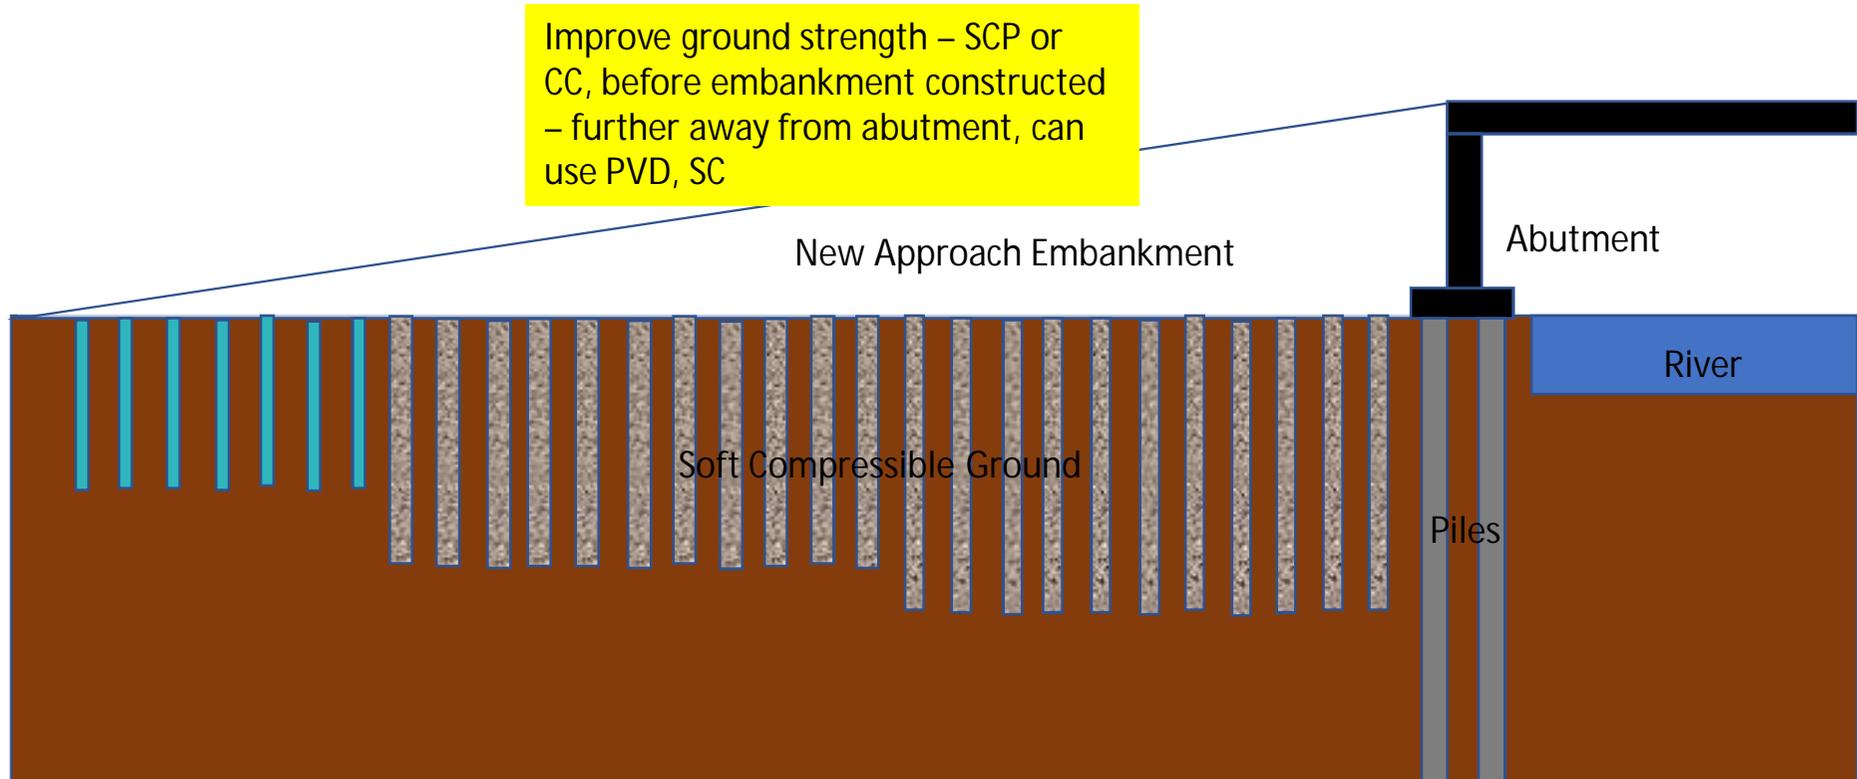
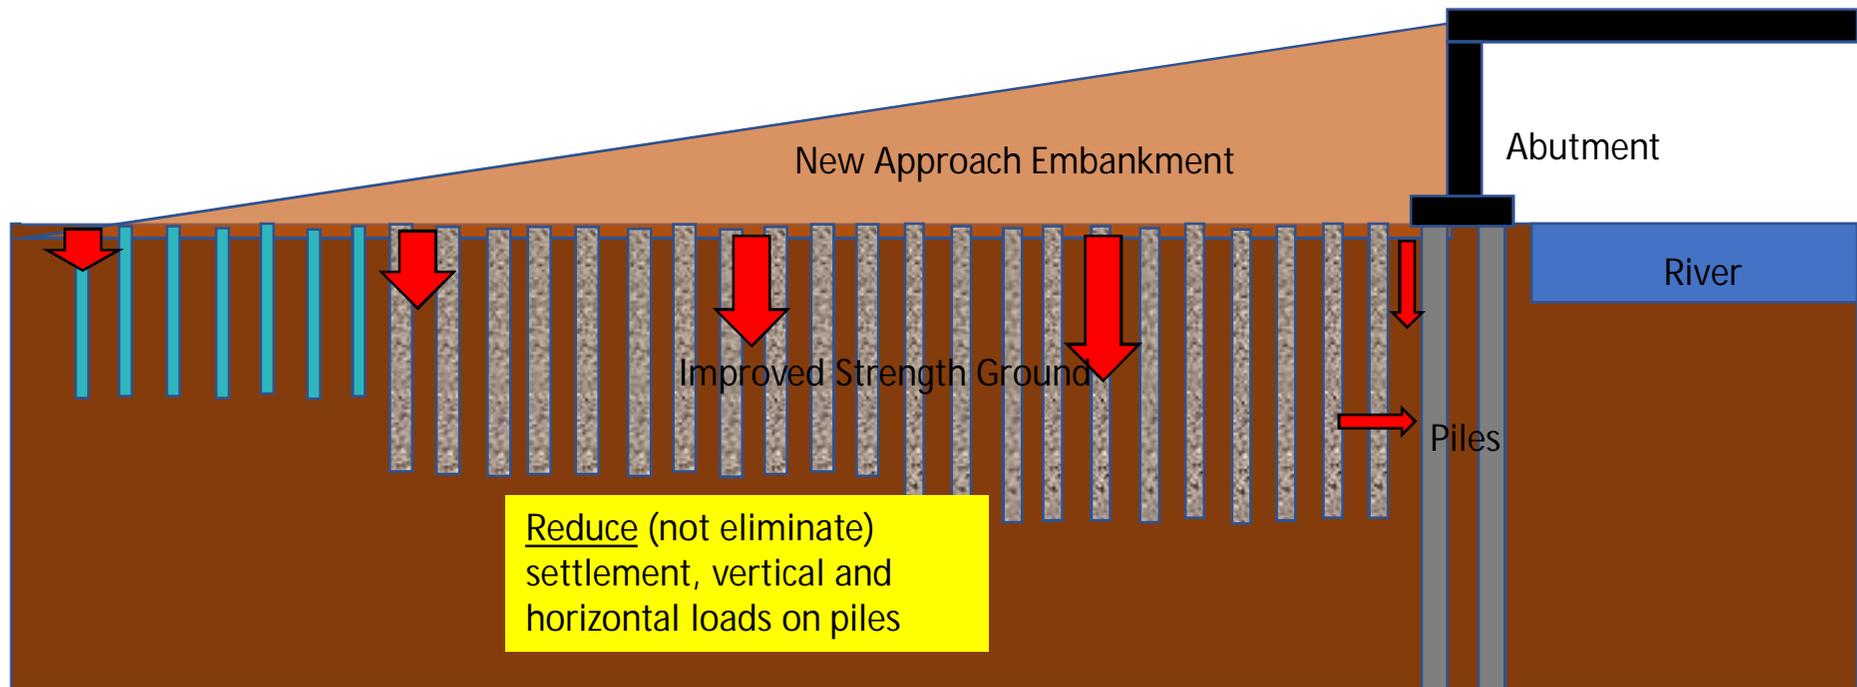
Build bridge first – support abutment with piles + support embankment with SCP or CC

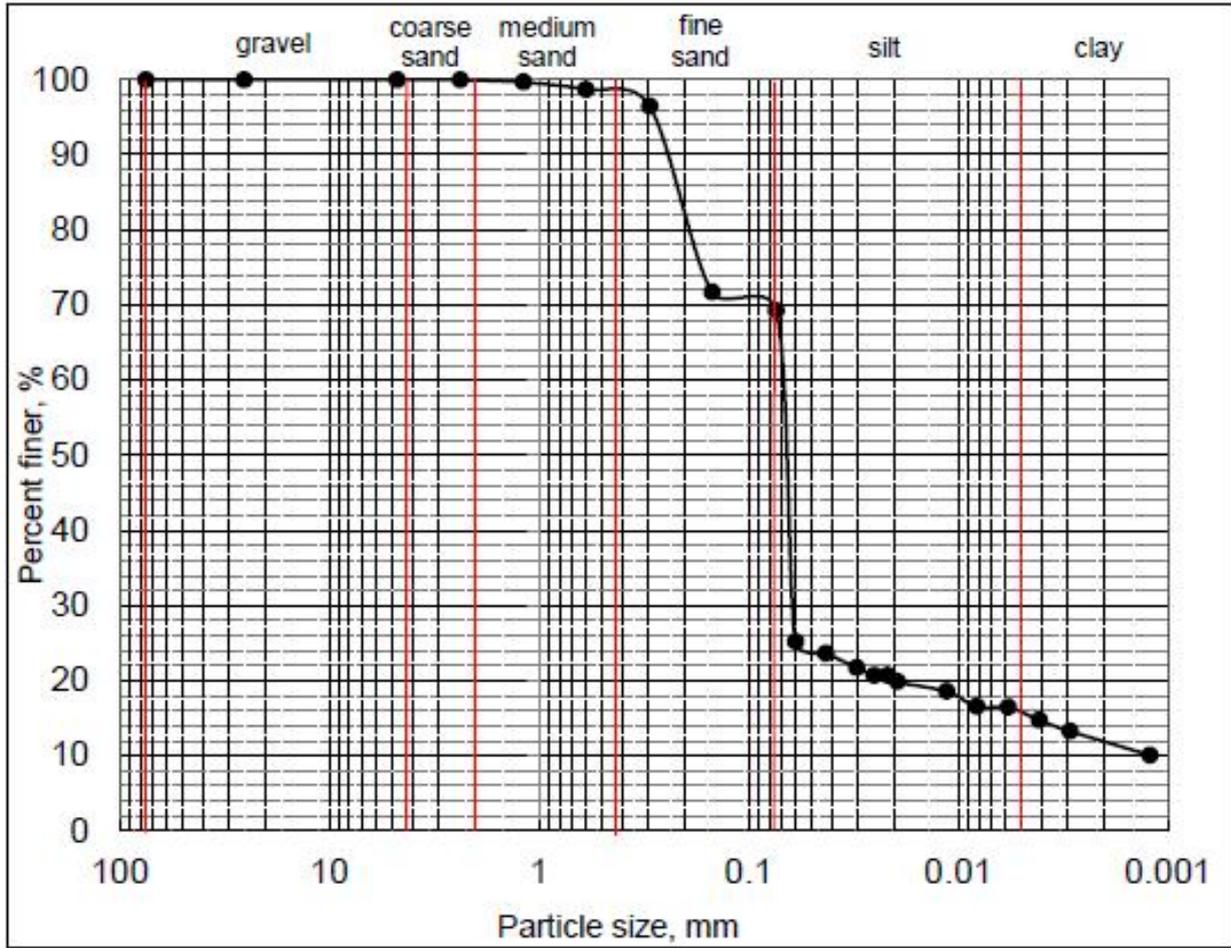
PSD Plot for Sample 2, Site 3

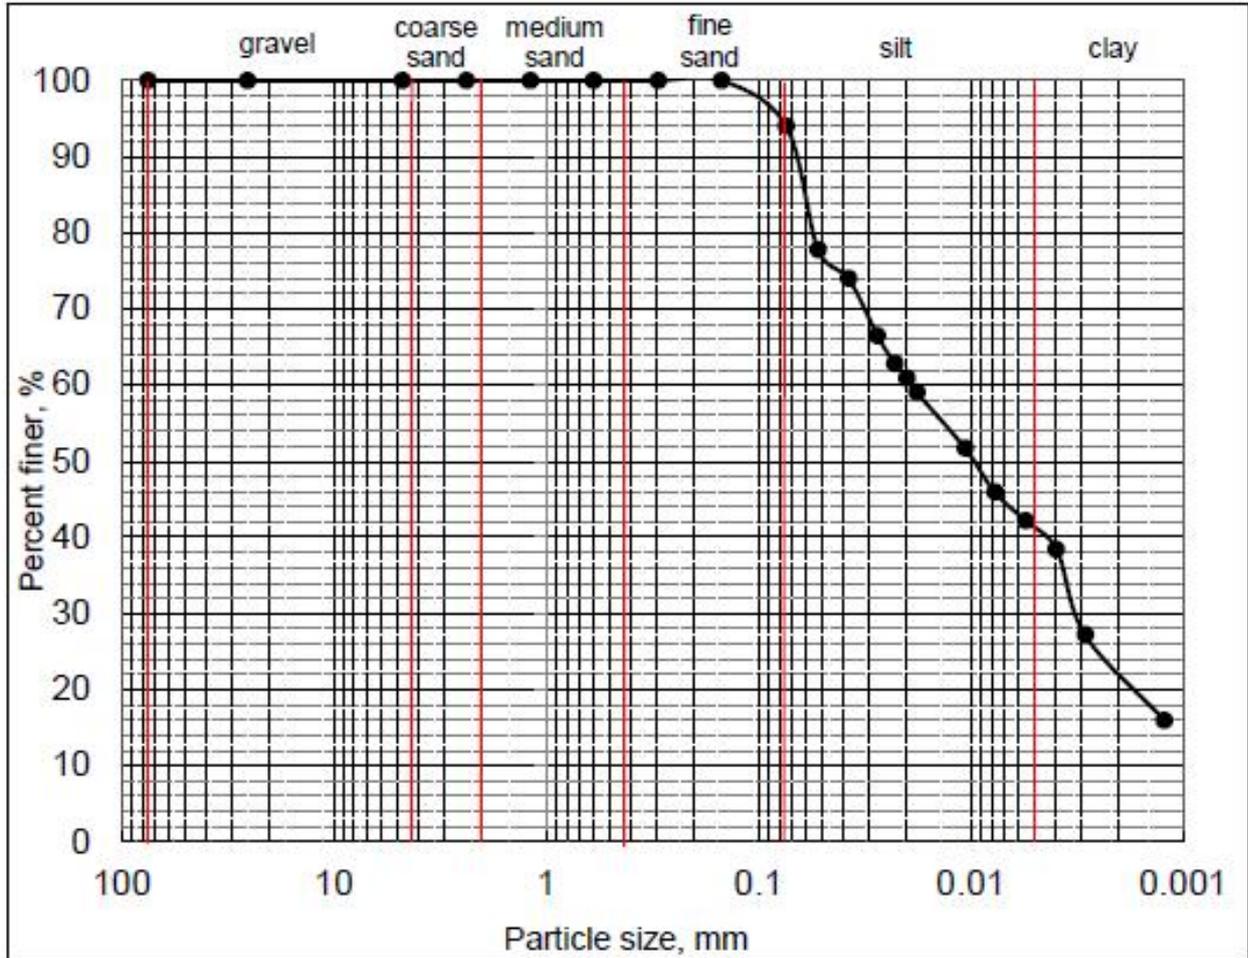
PSD Plot for Sample 1, Site 10

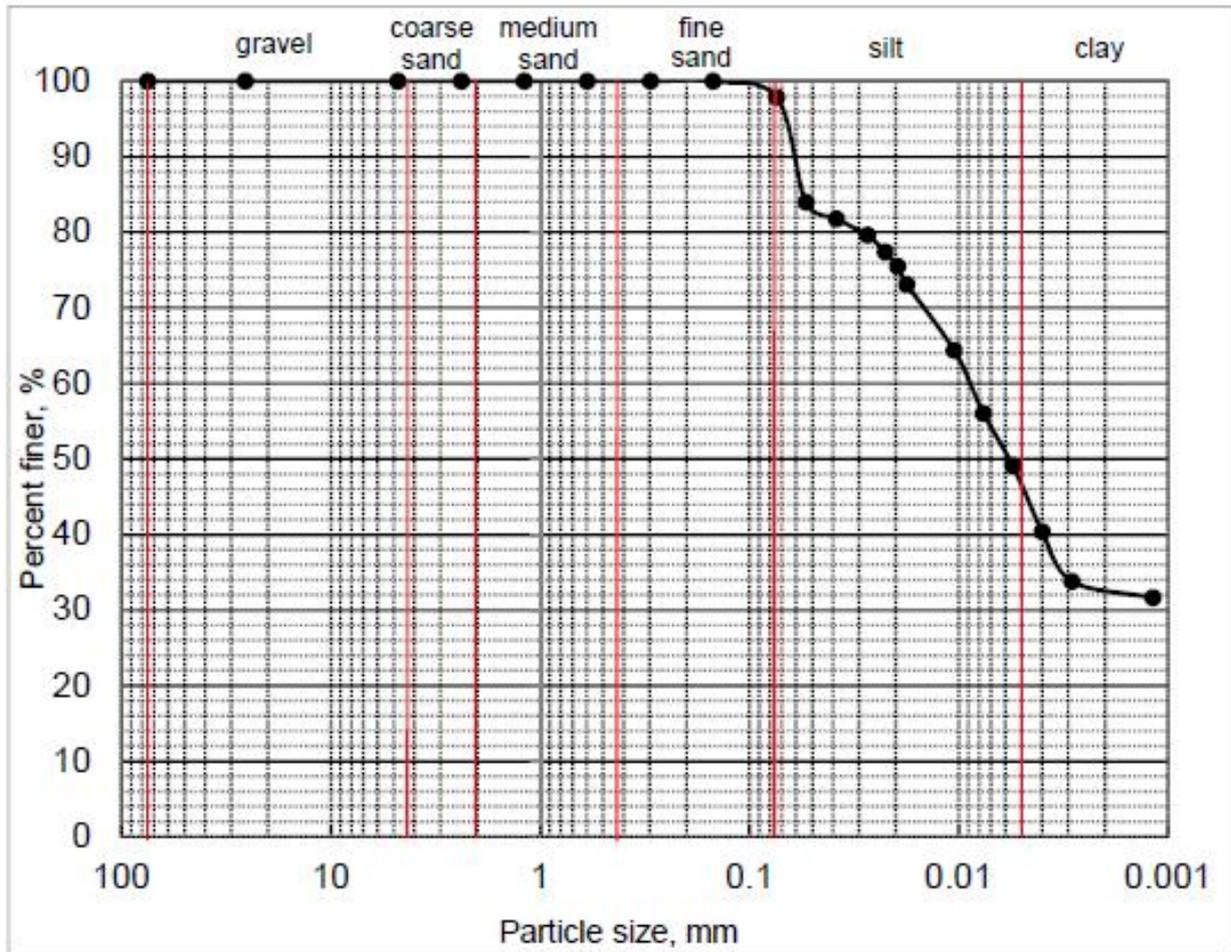
PSD Plot for Sample 3, Site 11
